U.S. CHEMICAL SAFETY AND HAZARD INVESTIGATION BOARD

INVESTIGATION REPORT

PETROLEUM PRODUCTS FACILITY INCIDENT

THIRD COAST INDUSTRIES

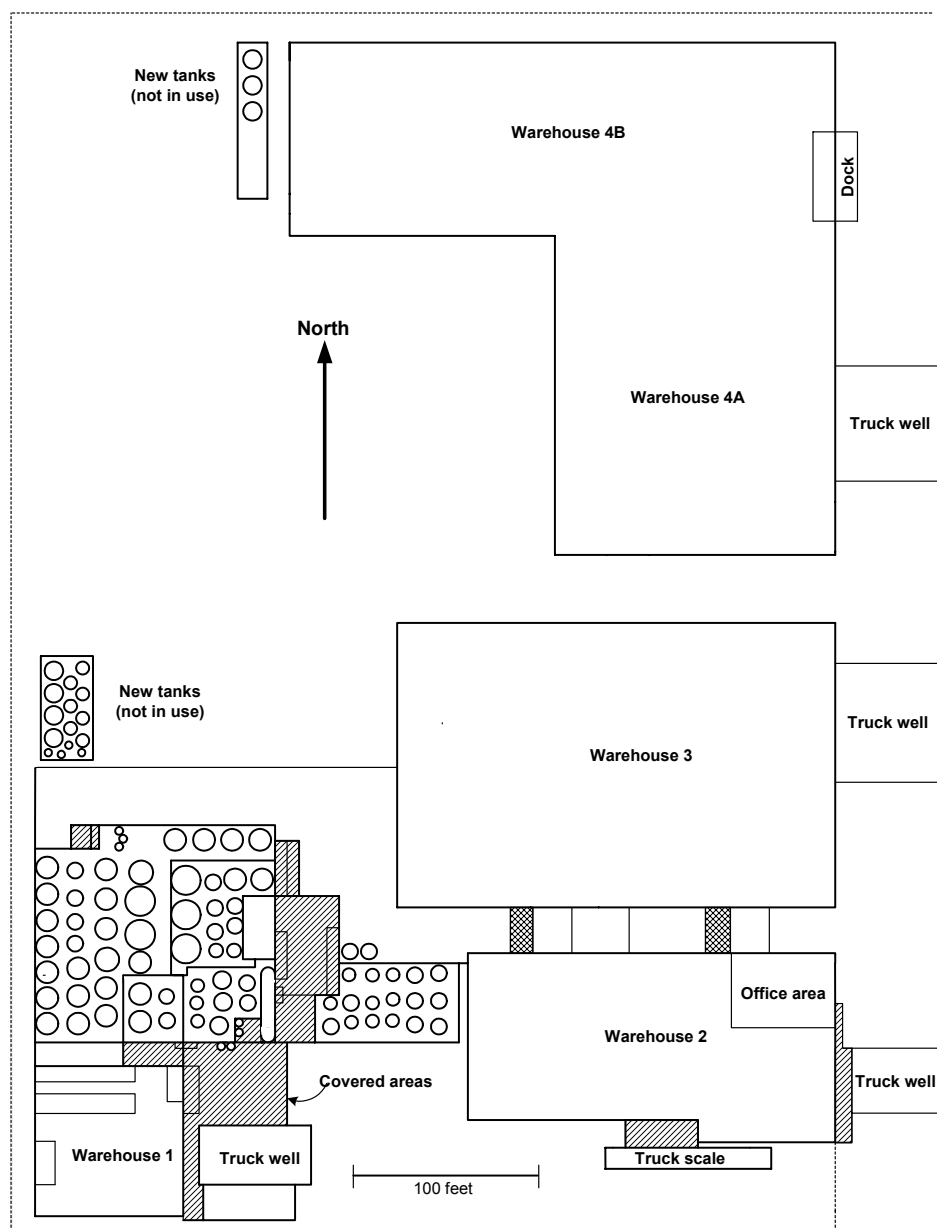
Figure 1. Layout of Third Coast Industries facility.

Third Coast Industries was located on West Clover Lane, in an unincorporated section of Brazoria County, near Friendswood and Pearland, Texas, approximately 18 miles southeast of downtown Houston.² The company was formed in 1987 and began operations in 1988. Figure 1 shows the layout of the facility.

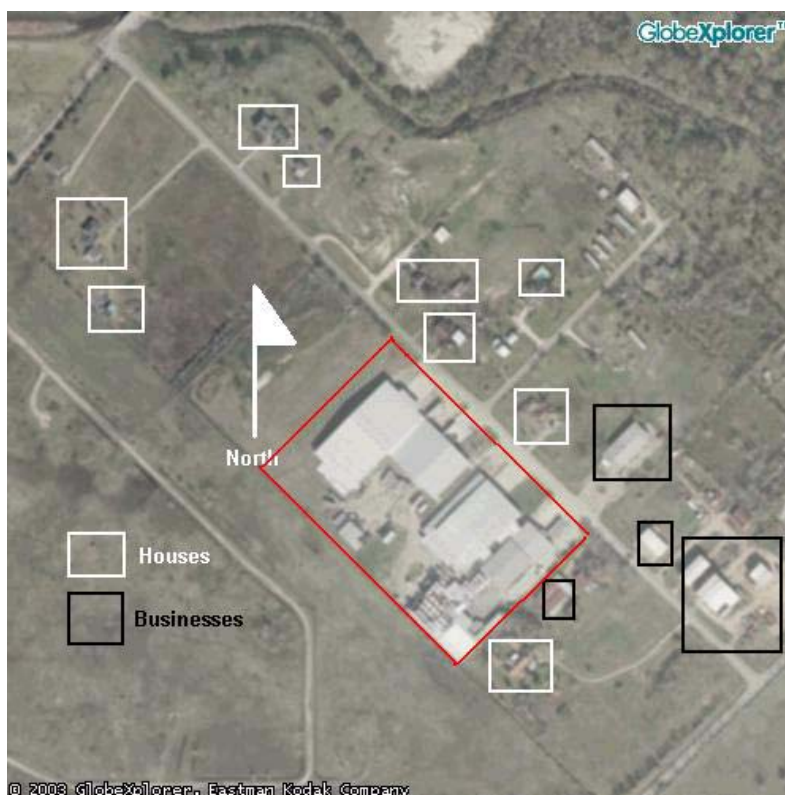
Figure 2. Third Coast facility, prior to fire.

acres of land were acquired in the late 1990s. In 2000, an additional 7 acres was purchased, and warehouse 4B was added to the complex. At the time of the fire, Third Coast employed 100 people at the Friendswood site. (The only other Third Coast facility—Third Coast Terminals—is located within the city limits of Pearland, Texas.) Figure 2 presents an aerial view of the site, showing nearby homes and businesses.

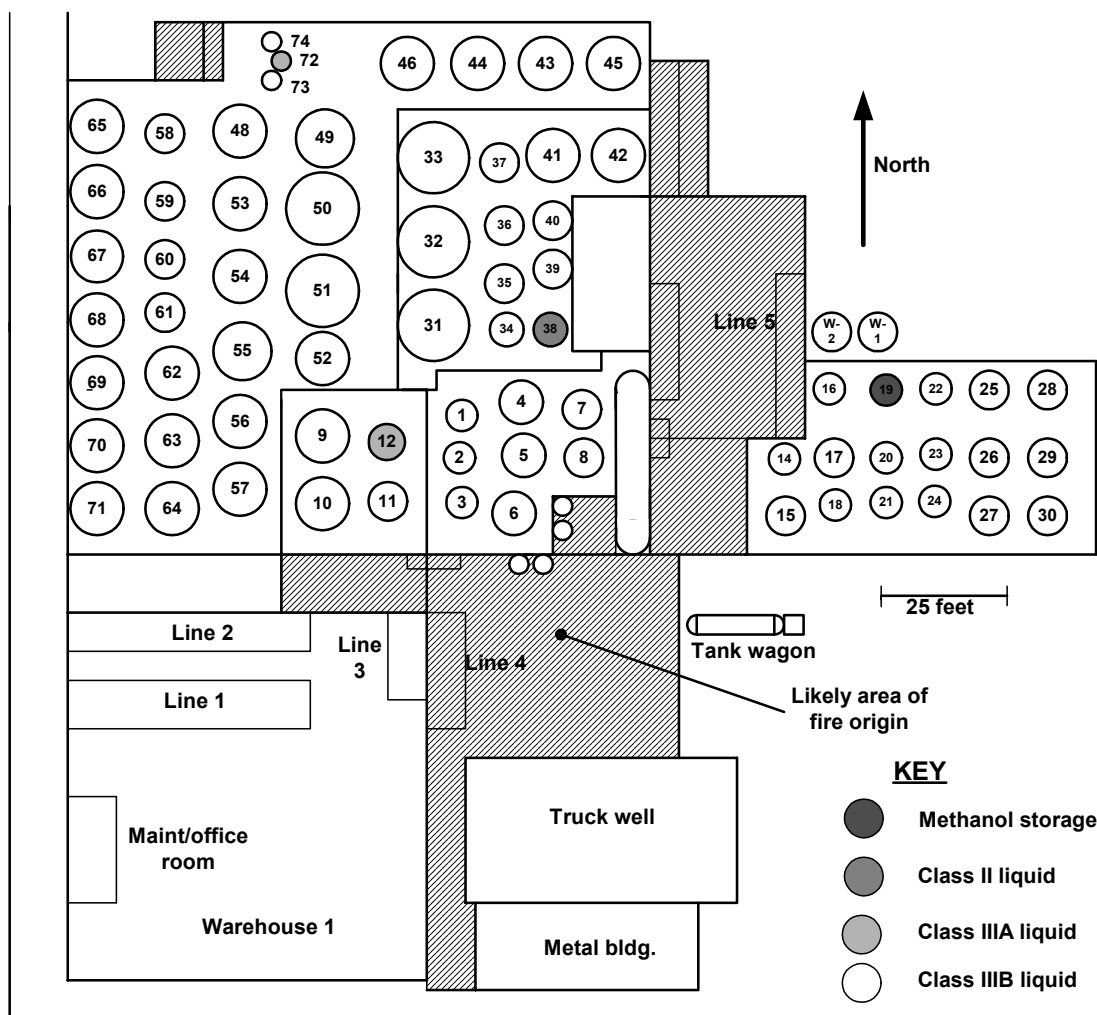
Figure 3. Third Coast storage tank farm.

Seventy-four storage tanks were in use at the time of the fire (Figure 3). Another 18 storage tanks were installed, but not in use. The storage tanks were divided among five diked areas. The rudimentary diking generally consisted of two courses of hollow masonry blocks.

CSB estimates that 735,000 gallons of bulk combustible and flammable liquids were onsite at the time of the fire.
